Residual Risk

An Account of Events in Nuclear Power Plants Since the Chernobyl Accident in 1986

May 2007

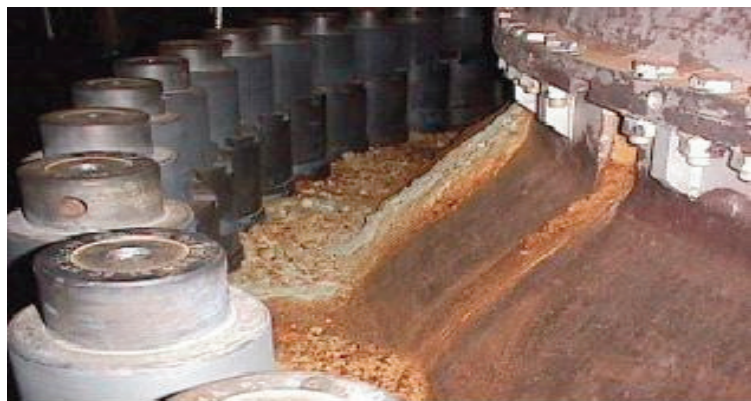
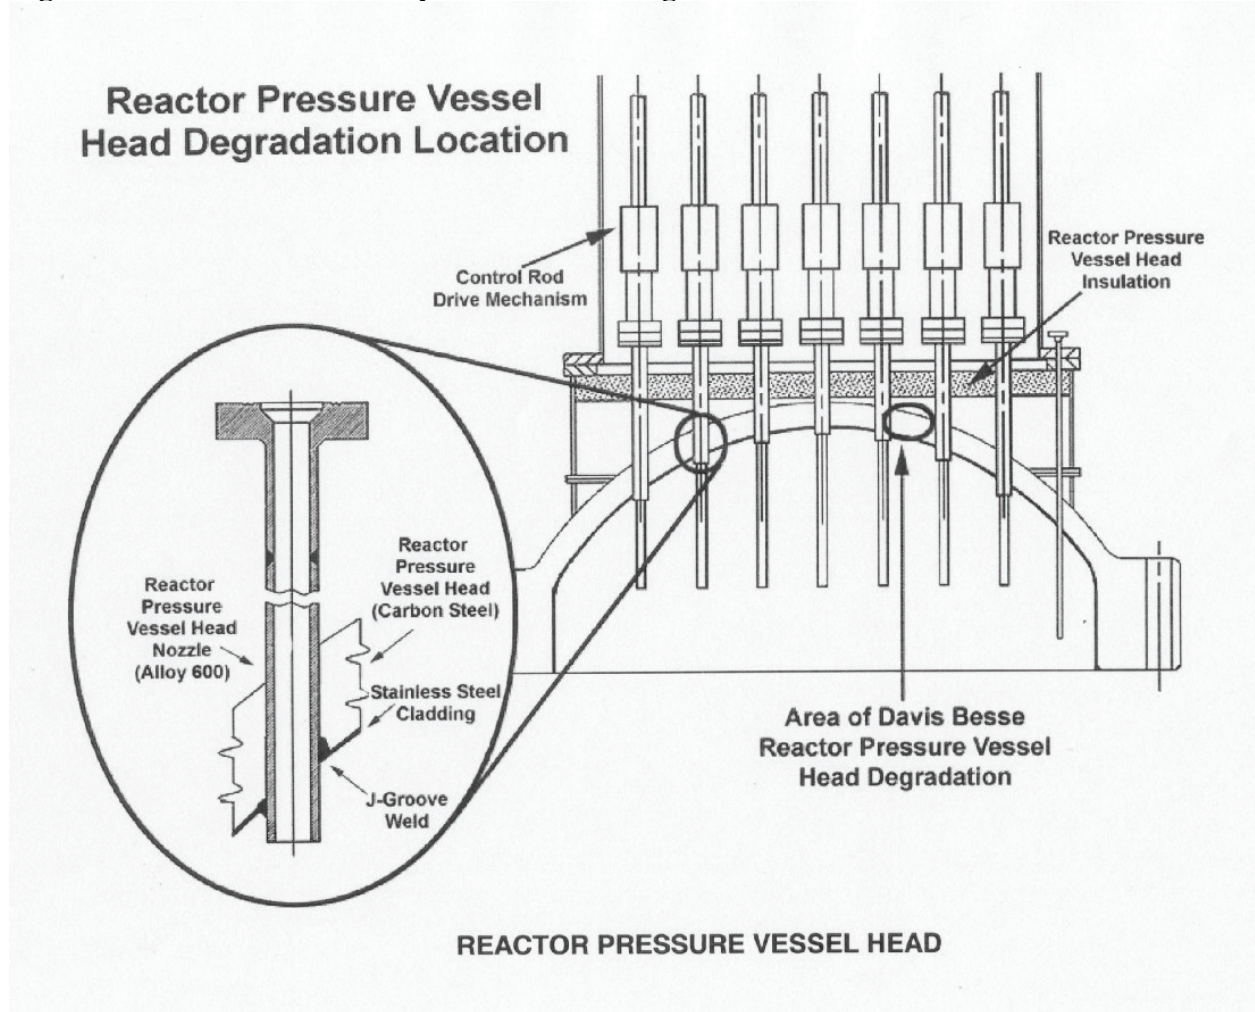
Figure 8: Davis Besse reactor pressure vessel degradation

Rust-laced boric acid "river" flowing through inspection ports on the reactor head and down onto the reactor flange during the refueling outage in 2000.

When the leaked water evaporated, it left behind dry boric acid crystals. Boric acid is very corrosive to carbon steel. It began eating through the carbon steel head. By 2002, there was a pineapple-sized hole in the head. The boric acid had completely eaten through the 150mm thick carbon steel wall to expose the stainless steel liner. The liner was applied to the inner surface of the carbon steel reactor vessel and head for protection against the corrosive borated water. The liner was not intended to be pressure-retaining, but for years it was the only barrier preventing a loss of coolant accident. As boric acid widened the hole, the stress loading of the liner increased. A government study estimated that the hole would have widened to the point where the liner ruptured in another 2 to 11 months of operation by Davis-Besse. Because Davis-Besse ran 18 months between refueling outages, had the damage been missed during the 2002 outage, it seems likely that a loss of coolant accident would have occurred.

Many warning signs had been overlooked since the leak began in 1996. During refueling outages in 1998 and 2000, workers discovered boric acid blanketing large portions of the reactor head. Nearly a decade earlier, the company had committed to the NRC to completely clean up all boric acid spills to check if there was corroded metal underneath. Workers attempted to remove the boric acid from the head, but management did not extend the outage duration to allow them to finish the work. During 1999, small rust flakes blowing up into the air from the widening hole clogged the filters on monitors inside the containment that continuously sampled the air for radioactivity. Management sent workers into

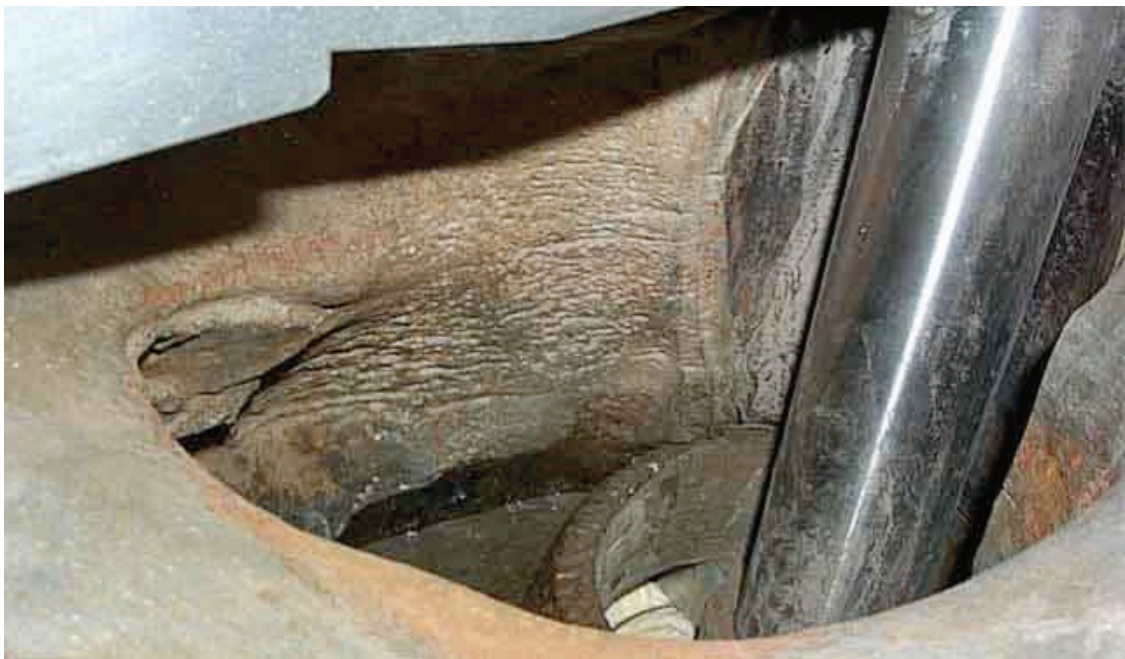
Had the 5mm stainless steel liner ruptured, a hole with a diameter of approximately 250mm would have created a medium-sized loss of coolant accident. While Davis-Besse was equipped with emergency systems to mitigate such an accident, these backup systems were also found to be impaired. The worst problem involved the containment sump used during the second phase of accident mitigation. In the first phase, emergency pumps transfer water from a large storage tank adjacent to the containment building into the reactor vessel to compensate for the cooling water pouring out the 250mm diameter breach. The water pouring out of the reactor drains to the bottom of the containment building where it collects in a concrete pit called the containment sump. Before the storage tank empties in about 30 to 45 minutes, the operators realign the emergency pumps to take water from the containment sump and send it to the reactor vessel. Workers found that the debris created by water jetting out through the hole (e.g., insulation and coatings scoured off piping and components) in addition to pre-existing debris inside containment (e.g., paint applied to the inner surface of the containment dome

The large hole in the reactor vessel head around the vessel head nozzle.

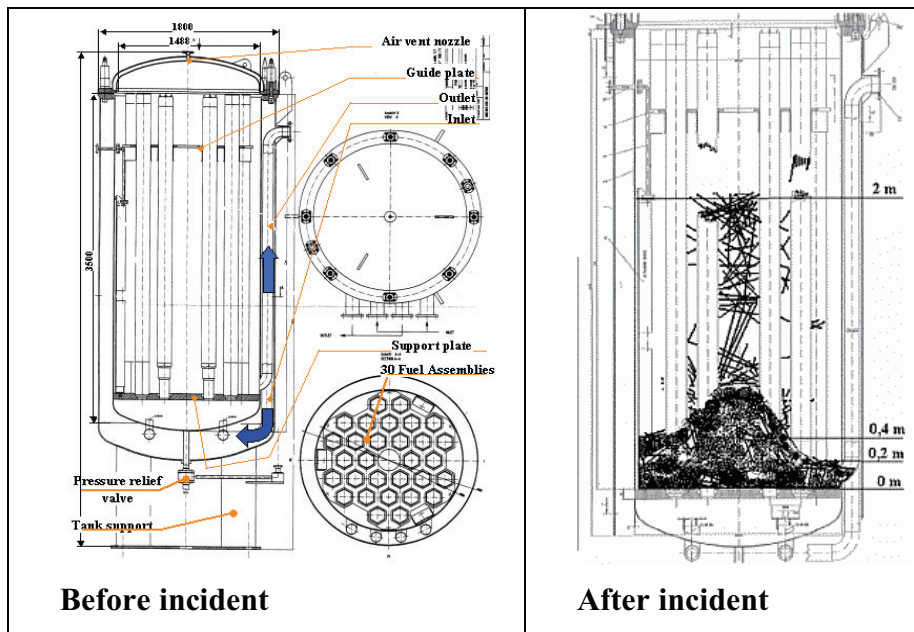
Figure 9: Paks Fuel Cleaning Tank Before and After the Incident

- Location of a pressure relief valve at the bottom instead at the top of the tank, which led to malfunctioning of the cooling function;
- Inadequate sizing of the submersible pump, whose redundancy and back-up system was also inadequate. The low-capacity pump had to operate for several hours after completion of the cleaning which was clearly beyond its design specifications;
- The tank design did not assure precise positioning of the bottom end of the fuel assemblies in the cleaning tank;
- Only one fuel guide plate in the cleaning tank was utilized, which cannot assure proper alignment of the fuel assemblies. The possible bypass flows around the fuel assemblies – thus not fulfilling its cooling function – were not fully taken into account;
- Instrumentation, trend recording and alarms provided to detect off normal conditions were inadequate.

A number of significant aspects of this cleaning project were unique and unproven. It was to be the first time that a large number of assemblies with significant decay heat were being cleaned. However, the safety analysis performed for the fuel cleaning provided only a simple analysis of the cooling conditions of the fuel. Even that analysis identified that in the event of loss of cooling during cleaning, boiling in the tank could occur within only 9,2 minutes. The approach proposed by Framatome ANP to respond to a loss of cooling was to stop the cleaning operation and to open the cover of the tank in order to flood the fuel. However the emergency lifting of the lid was not analyzed and there were no practical exercises. There was no analysis provided for the effects on the fuel assembly cooling if it was not properly installed in the tank, or of blockage of a fuel channel during the cleaning process. The safety analysis submitted with the license application also did not address the possibility of serious fuel cladding failure and the radiological releases expected from a single fuel element failure or multiple fuel failure. The lack of this information during the event contributed to an initial misdiagnosis of the incident.⁸²

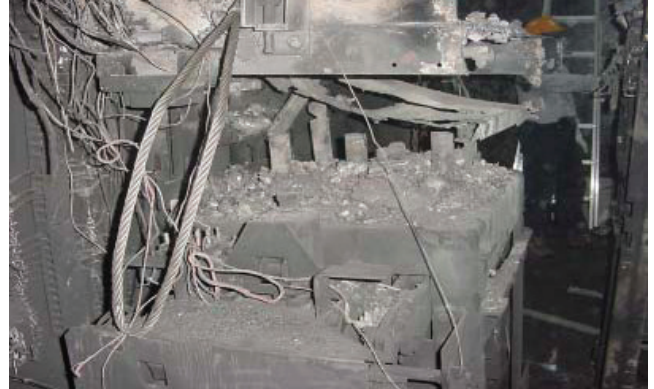
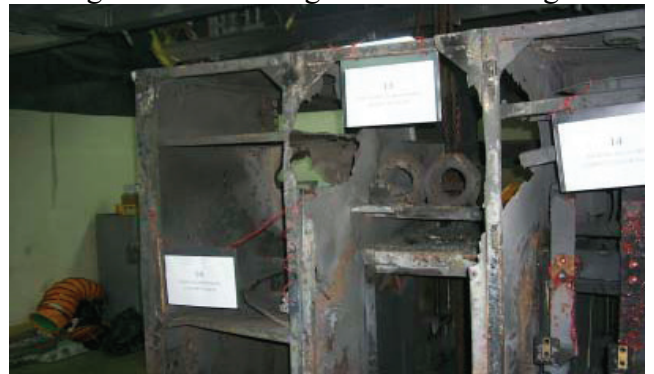
Figure 11: Breaker Damage at Maanshan During Station Blackout

Damaged Breaker

Damaged breaker arrangement at a switchgear
