Flawed Reactor Pressure Vessels in Belgian Nuclear Plants Doel-3 and Tihange-2

Some Comments

Ilse Tweer

January 2013

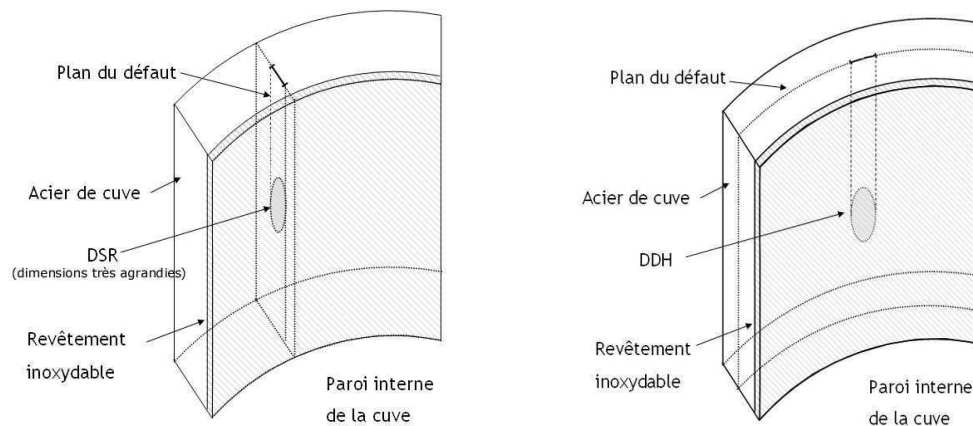
Figures 2a and 2b: Underclad cracks (a) and hydrogen-induced flaws (b)

While underclad cracks are directly under the stainless steel cladding oriented normal to the inside surface of the RPV wall, the observed flaws are parallel to the wall surface (see the following figures⁹; DSR¹⁰ are underclad cracks, DDH¹¹ the hydrogen-induced flaws).
