Residual Risk

An Account of Events in Nuclear Power Plants Since the Chernobyl Accident in 1986

May 2007

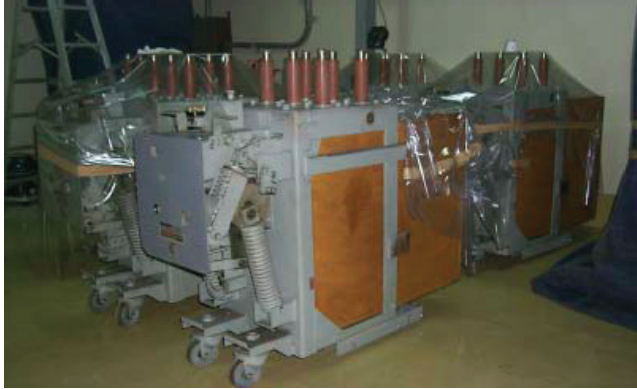
Normal Breaker

It turned out that the operator should have declared the event much earlier, as soon as the station blackout situation occurred. The breaker fault at the 4 kV essential bus is considered as the main cause of the event. The breaker and the switchgear got totally destroyed by the fire (see figure 11).

Figure 11: Breaker Damage at Maanshan During Station Blackout
